Mechanical and biochemical effects of man-made fibres and metals in the human eye, a SEM-study

W.L. JONGEBLOED¹, M.J. FIGUERAS², D. HUMALDA³, L.J. BLANKSMA⁴
and J.G.F. WORST⁵

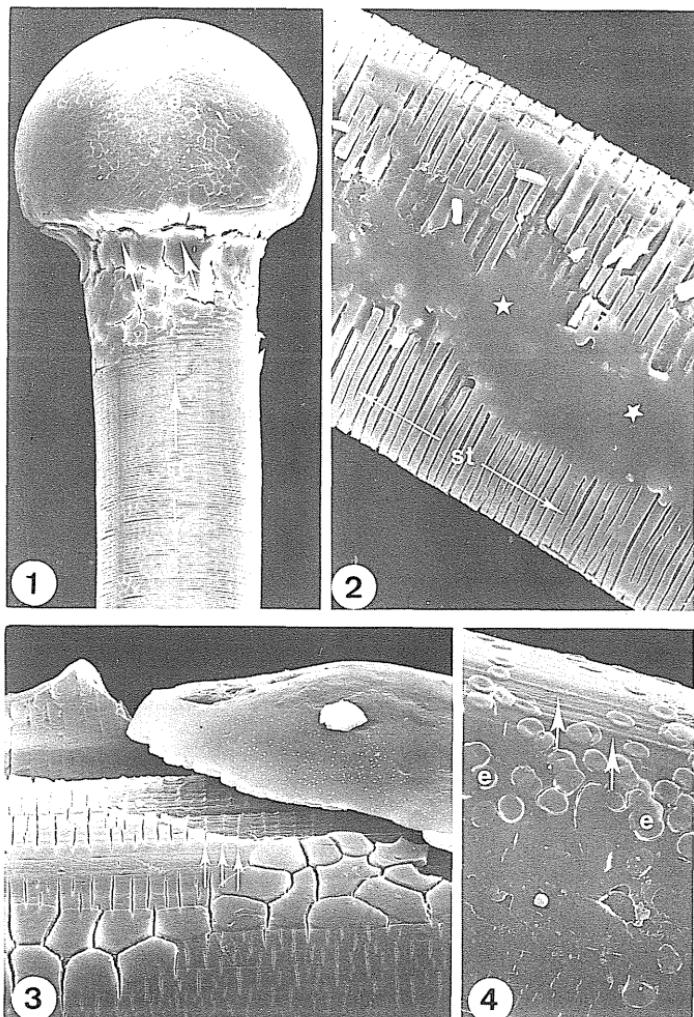
Both prolene loops showed severe degradation of the surface layer. Figure 1 shows part of one of the loops with a very regular pattern of striations (st) perpendicular to the longitudinal axis of the loop. The rounded end of the loop and the beginning of the straight part of the loop are covered with a rather thick layer of deposits of an unknown substance which contains many erythrocytes (e). The irregular cracks in this deposit (see arrows) are due to drying, a common phenomenon in SEM-specimens of inhomogenous structure. Figure 2 shows at higher magnification the very regular pattern of striations (st); some parts of the surface are covered with a thin deposit (*), comparable to the layer seen in Figure 1. The degradation of the surface layer can be observed in more detail in Figure 3. Part of the surface layer is detached, exposing the *sub-surface* layer, which shows a similar cracking pattern (see arrows). Although the cracking can have been enhanced by the drying process, the loops and lens were dried in air, the fact that the *sub-surface* layer shows a similar cracking pattern of degradation is a clear indication of biodegradation. If the phenomenon we observe were the result of the drying of a deposit, then the cracks in it would have a much more irregular character, like the cracks seen in Figure 1 on the rounded top. Moreover the total diameter of the degraded loop has certainly not increased, which would be the case if the result we observe was caused by the deposition of material.

That part of the loop (close to the lens) which was not in contact with tissue did not show the degradation phenomenon, but was merely covered with a very thin deposit, consisting mainly of erythrocytes (e), Figure 4. The layer of deposit is very thin, as can be concluded from the longitudinal lines, caused by the manufacturing process, which are still visible despite the deposit (see arrows).

Figures 1–4. Prolene: Figure 1 (155 X), part of prolene loop; e = erythrocyte covering; st = striations of biodegradation; arrows denote deposited organic matter. Figure 2 (370 X), degraded surface; * = deposited organic matter; st = regular pattern of striations. Figure 3 (770 X), detail of degraded surface layer. Figure 4 (370 X), non-degraded prolene surface; e = erythrocytes; arrows denote manufacturing grooves.

We think that the surface changes observed in the implanted prolene are the result of biodegradation by the enzymatic action of the tissue fluids. Although the cracking pattern on the surface may be enhanced by the drying, the changes are the primary result of chemical changes on the surface.

This conclusion is supported by the images of the *sub*-surface layer, where lines appear perpendicular to the longitudinal axis of the loop, which are not present in the control sample. In some places a deposit is visible on top of the surface layer of the implanted prolene; this layer is very thin and not in any way comparable with the attacked layer. If the phenomenon of what we call biodegradation is the result of a deposit of, for example, a proteinic material, a quantitative increase in the average diameter would be the result. The total diameter at such sites did not increase but, on the contrary, tended to decrease slightly. Moreover the cracks (striations) are so regularly spaced over a large part of the implanted loops that they must be the result of prolene degradation and not of the mere drying of a deposit.

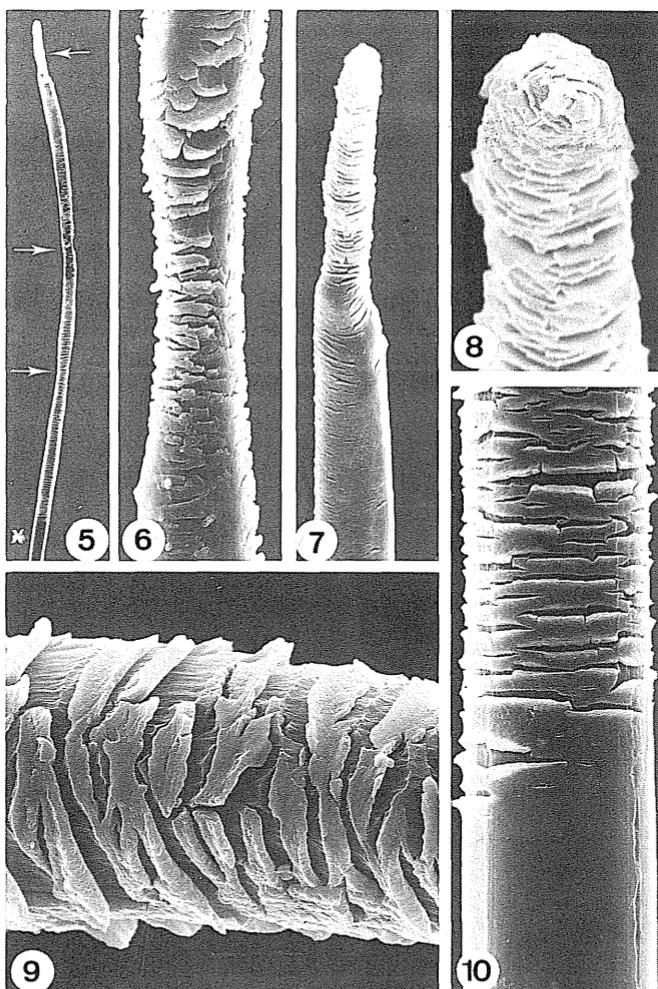
not show this. The attack was so serious that the ends became so thin that they lost their strength and broke off. Figure 5 shows the broken end of one of the sutures at low magnification. In several places (see arrows) the suture had a smaller diameter than average. This considerable decrease in diameter is something we did not observe with prolene. The main part of the suture in Figure 5 shows a degraded surface, except for the part indicated by (*).

A thinner part of the suture is shown in more detail in Figure 6, the

Figures 5–10. Perlon: Figure 5 (38 \times), low magn. broken Strampelli suture; arrows denote decreased diameter; * = non-degraded part. Figure 6 (390 \times), detail of suture with decreased diameter. Figure 7 (175 \times), broken end of suture. Figure 8 (595 \times), detail of Figure 7. Figure 9 (1330 \times), detail of degraded surface. Figure 10 (450 \times), transition non-degraded (lower part) – degraded surface.

surface of the suture is degraded. The broken end of the suture is depicted in Figure 7, it has a considerably decreased diameter and the surface is degraded. The broken end is shown in Figure 8 at high magnification, note the rough outer surface.

prolene. That part of the suture which had not been in contact with tissue did not show these effects of biodegradation. Figure 10 shows such a transition area in more detail, the lower part of the picture represents the non-degraded surface of the perlon structure.

The effects seen in the perlon material are also the result of biodegradation; in certain places the material got so thin that it lost its strength and broke. Supramid material showed minor degradation effects, longitudinal cracks which may be related to the manufacturing grooves to some extent. In one case (see Addendum) we found, in a very small portion of the total length of all the loops, a similar degradation effect to that seen in prolene and perlon. Thus supramid can undergo biodegradation as well.

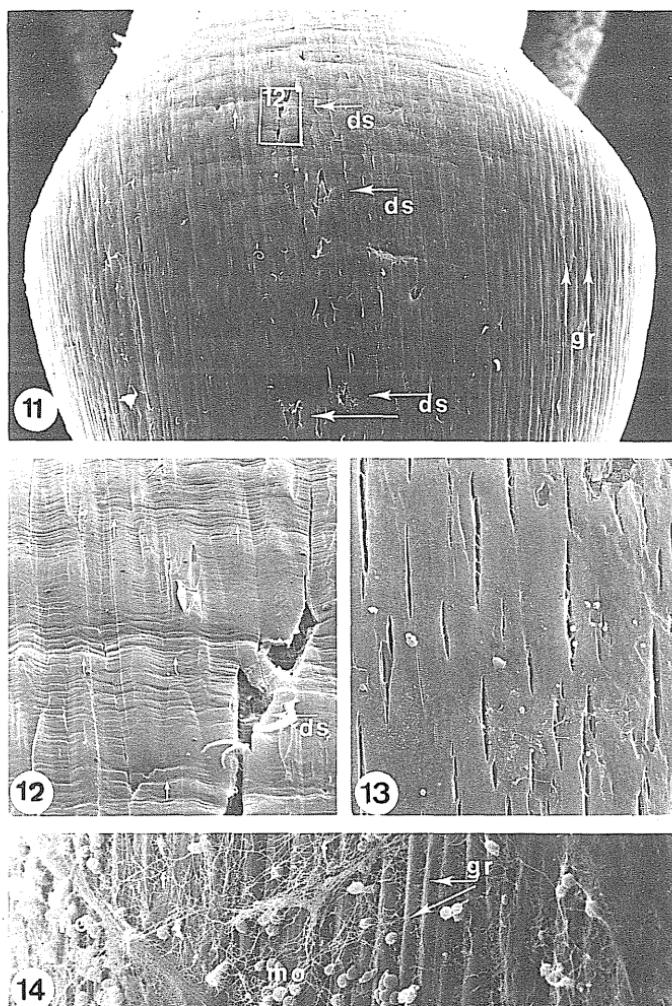
Figures 11–14. Supramid: Figure 11 (455 \times), bend in loop; gr = manufacturing grooves; pl = lines perpendicular to grooves; ds = surface damage. Figure 12 (1530 \times), detail of Figure 11. Figure 13 (950 \times), longitudinal cracks in surface. Figure 14 (1530 \times), gr = manufacturing groove; f = fibres; mo = microorganisms.

The supramid material showed, in particular at bends in the loop, a fine network of lines (see arrows) perpendicular to the longitudinal manufacturing grooves (gr) of the loop (Figure 11). On the median part of the loop, clear evidence of surface layer damage can be seen (ds). Figure 12 shows a detail of such a site and its relationship to the fine network already mentioned. In Figure 13 longitudinal cracks are visible on the surface of the supramid loop, possibly the start of biodegradation. These cracks are found in the vicinity of bends in the loop at some distance from them, implying that this type of degradation is related to weak spots in the loop, particularly bends due to the manufacturing process. The general pattern of the surface is not one of severe degradation, as compared to the degradation seen in prolene and perlon, at least not in the loops we investigated.

The relatively rough outer surface of supramid, as compared with prolene and perlon, certainly facilitates the adherence of fibres, cells and micro-organisms, as can be seen in Figure 14. The picture shows the almost complete diameter of the loop with fibres (f), possibly fibrin, and microorganisms (mo) covering the manufacturing grooves (gr) of the supramid.

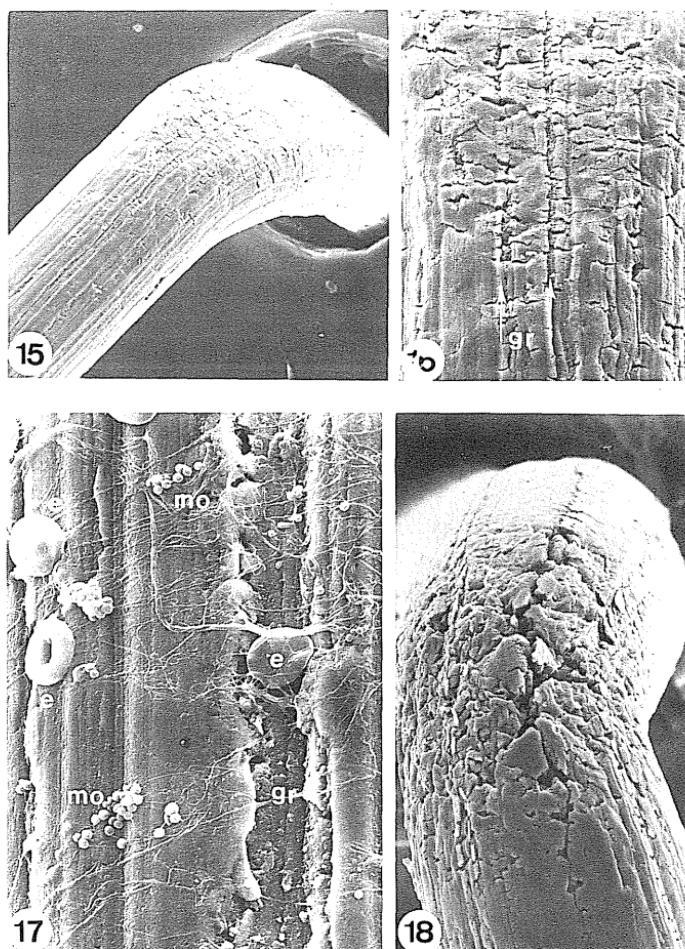
Titanium showed a rough outer surface, particularly at bends in the loop; in the straight part of the loop the longitudinal lines can be seen caused by the manufacturing process (Figure 15). The longitudinal grooves (gr) and the cracks more or less perpendicular to them can be seen in more detail in Figure 16 (area (A) of Figure 15). The roughness of the titanium surface facilitates the adherence of microorganisms (mo), fibre-like material and cells, especially erythrocytes (e), visible against the background of manufacturing grooves (gr) in Figure 17.

This roughness is already present in non-implanted material, as can be observed in Figure 18. The cracks in the surface layer particularly at the bends in the loop, visible in non-implanted as well as implanted material (see Figure 16), are some kind of mechanical degradation probably caused by, or at least initiated by, the manufacturing process.

This roughness also contributes considerably to irritation and inflammation of the tissue which is in contact with this material. In comparison with titanium, stainless steel-vanadium and, in particular, platinum wire have a much smoother surface.

Figures 15–18. Titanium: Figure 15 (190 \times), bend in implanted loop. Figure 16 (455 \times), detail of surface of bend; gr = grooves. Figure 17 (1230 \times), detail of loop surface; mo = microorganisms; e = erythrocytes; gr = manufacturing groove. Figure 18 (345 \times), detail of bend in non-implanted loop.

Both supramid and titanium have initially a rather rough outer surface, which facilitates adherence and, in the case of titanium, contributes to irritation and inflammation of the tissue with which it is in contact.

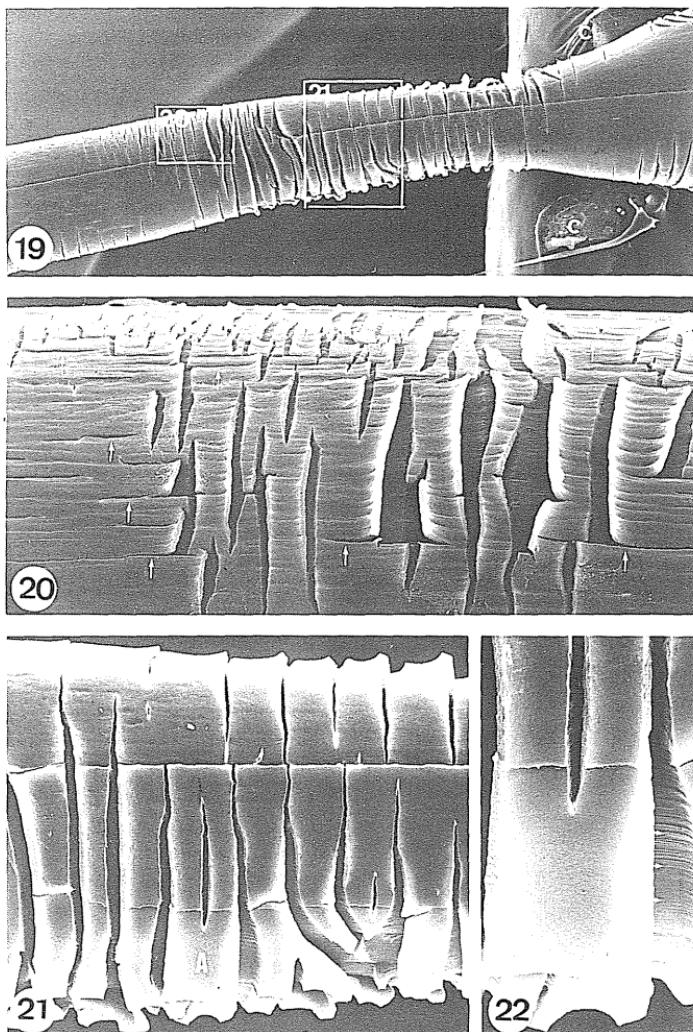
one loop situated close to the IOL (see Figure 19), which showed severe biodegradation. The diameter of the loop had decreased at this site. The IOL showed some cell deposits around the loop 'entrance' (c). The degradation pattern is quite similar to that found in prolene and perlon (see Figures 20 and 21, both details of Figure 19). From Figure 20 it seems logical to assume that the degradation is connected with the surface morphology of the supramid surface. The longitudinal cracks (see arrows) are comparable with those found in Figure 13, which can be related to the manufacturing grooves. The

Figures 19–22; Supramid: Figure 19 (75 X), part of loop close to IOL; c = cell deposit. Figure 20 (455 X), detail of Figure 19; arrows denote longitudinal cracks. Figure 21 (275 X), detail of Figure 19; severe degradation of surface. Figure 22 (610 X), detail of Figure 21, inside of crack.

striations perpendicular to these cracks are comparable with the striations¹ found in prolene (Figure 2) and perlon (Figure 9), although less regular.

Figure 22 shows more detail of the inner part of the surface layer (enlargement of part of Figure 21). From this picture we can conclude that the loosened surface layer does *not* have an amorphous structure, which would be the case if it was merely a deposit of, for instance, proteinic material. Arrows denote the cross-section of the loosened surface layer.
